Safety On Line

A Flight Safety Publication for all US Airways and
US Airways Express Flight Personnel

Spring 2006

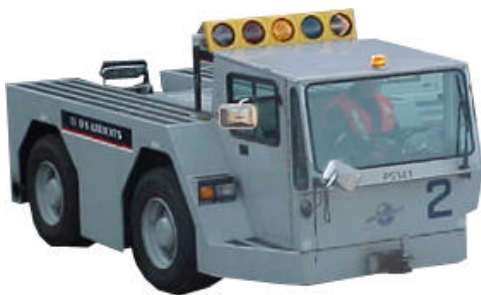
Severe Weather Parking System (SWPS) [See FOM 5.12.6 for complete system description and flight crew duties.]

US Airways uses this system when weather conditions restrict ground personnel access on the ramp. The system includes a light scheme (similar in design to a traffic light) mounted to a stationary vehicle positioned at the gate.

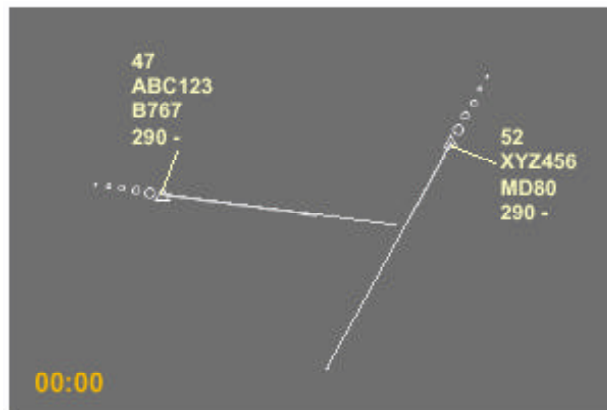
The figures below show how the situation was represented on the controller's radar display and the B767 TCAS traffic display, at the time of the initial traffic information.

Controller's radar display

On the controller's display, the 3 minute speed vector (magnetic track and speed) clearly shows that the B767 was going to pass behind the MD80 (which was faster: 520kts vs. 470 kts ground speed). This is not obvious on the TCAS traffic display.
